TO: Solid Waste Files  
Hill Co.\Unified Disposal District Landfill\Lic. #389\Groundwater Reports

SUBJECT: **Summary of Groundwater Monitoring at old Unified Disposal District Landfill,  
License #389**

**RE: UNIFIED DISPOSAL DISTRICT CLASS II LANDFILL – LICENSE #389  
JUNE 2014 GROUNDWATER SAMPLING REPORT**

RE: **UNIFIED DISPOSAL DISTRICT LANDFILL – LICENSE #389**  
**GROUND WATER MONITORING - REVIEW OF APRIL, 2006 SITE HYDROGEOLOGY REPORT**

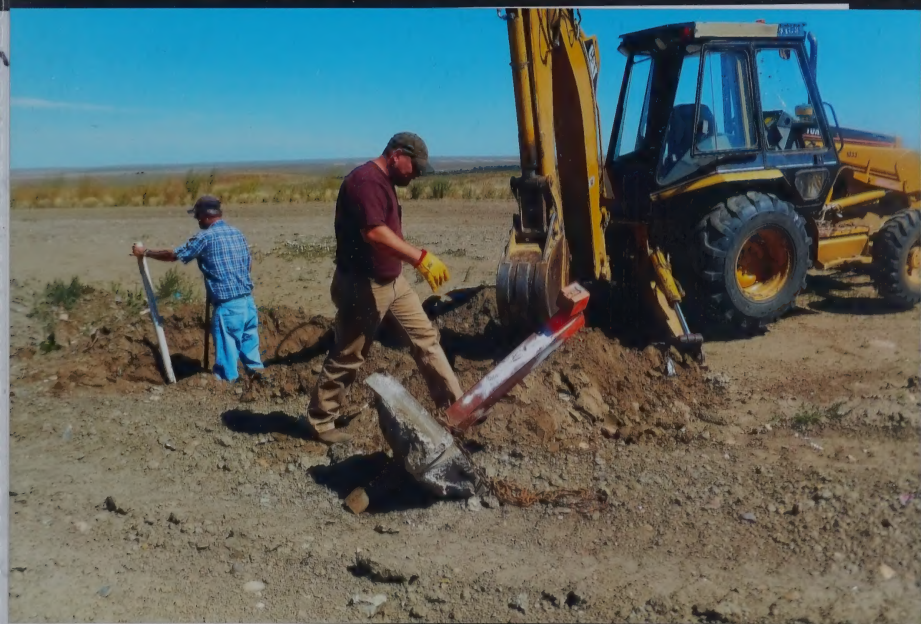
Unified Disposal District - License #389  
Fall 2012 Damaged Monitoring Well
